Preliminary Engineering Quiet Zones at Various Locations in Precinct 2

UPIN: 21102MF24101

Limits: From Fulton Street to W. Hardy Street Along the BNSF and UPRR Mainline Track

Prepared for: The Harris County Engineering Department

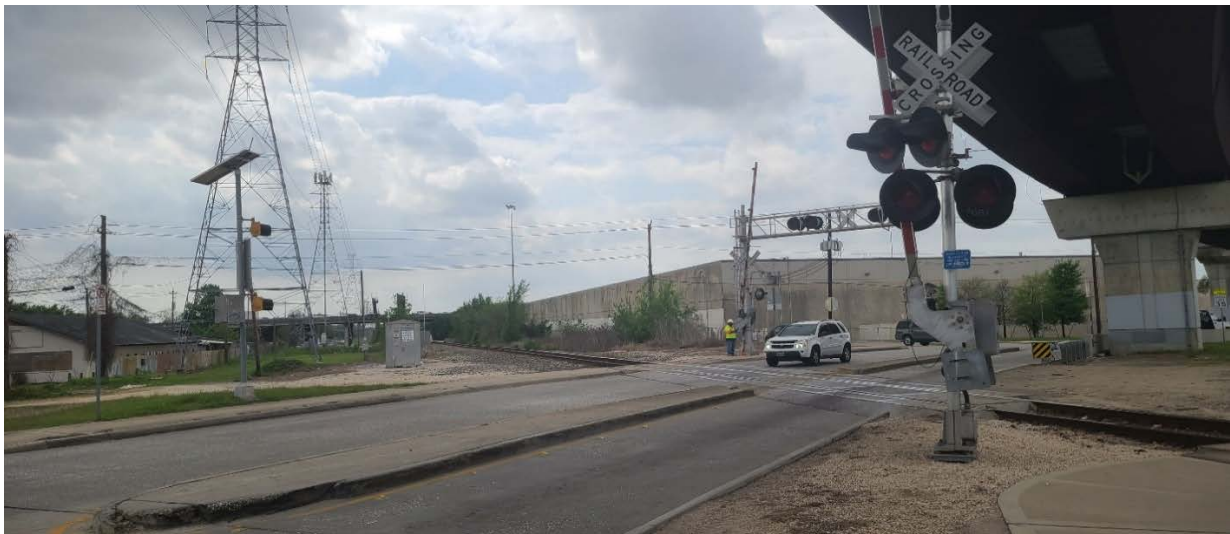
Figure 2a. Fulton Grade Crossing

- W10-1 signs on both approaches
- Faded RR Xing pavement markings on both approaches
- Faded stop lines on both approaches

- Reroute the existing sidewalk on the southbound approach behind the gate foundation as shown in **Figure 5** below.
- Replace RR pavement markings and stop lines
- Ensure gate arm length is within one foot of the raised median

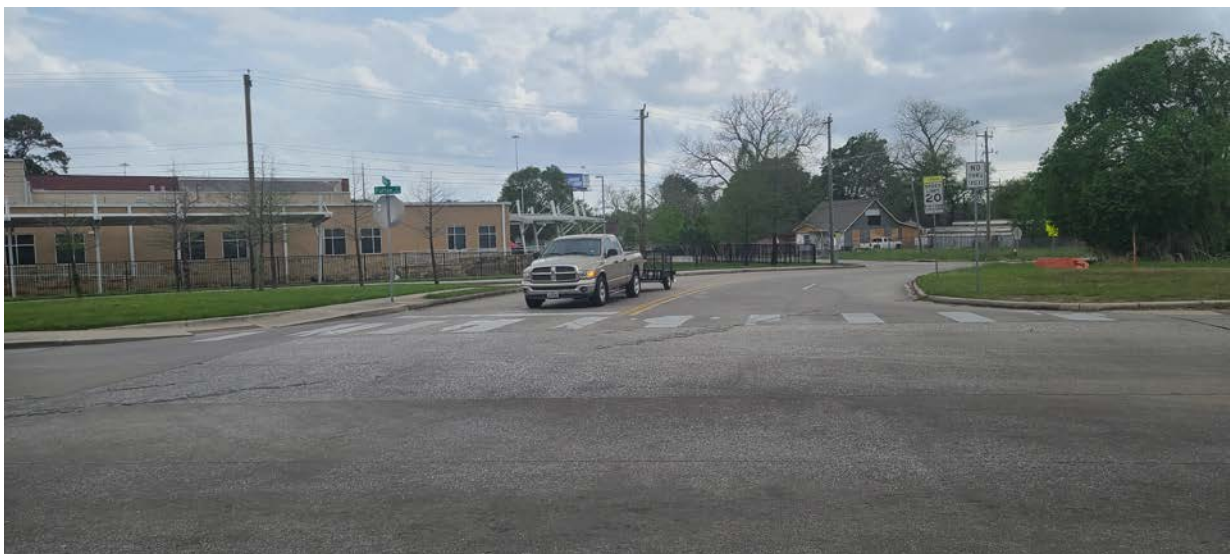
Figure 2b. Fulton Street at Stokes Street

The existing raised medians along Fulton Street do not have the required length to meet the FRA's quiet zone requirements. Since an intersection is found within 100 feet of each crossing gate, the medians must be at least 60 feet from the crossing gate. Neither existing median meets the minimum 60-foot length.

- Since Stokes Street is within 100 feet of the gate arm on the northbound approach, the exiting raised median must be extended at least 60 feet from the gate arm. Extending the existing raised median to 60 feet will eliminate the left-turn movements from and onto Stokes Street. Therefore, it is recommended that Stokes Street be realigned as shown in **Figure 5** to allow the existing median on the northbound approach to be extended to 100 feet. On the southbound approach,

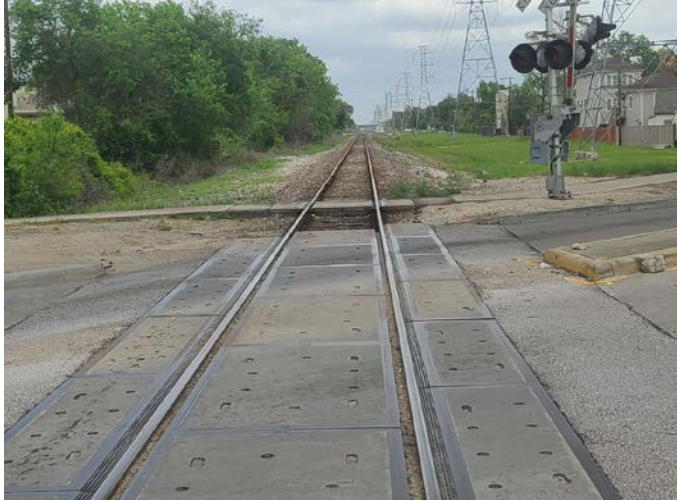
Figure 3. Sidewalk on northbound Fulton Street

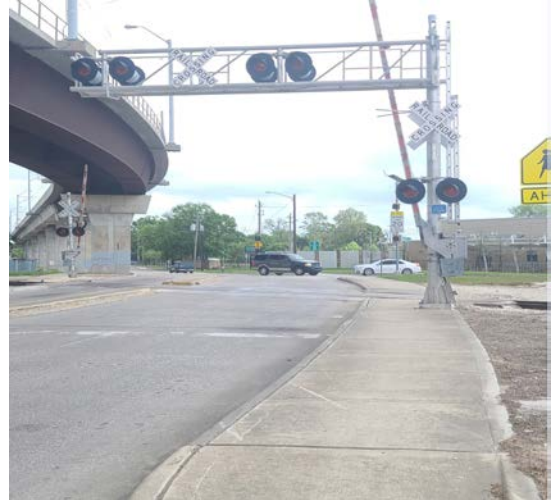
Figure 4. Sidewalk on southbound Fulton Street

The gate mechanism and foundation for the southbound approach encroach in the sidewalk and do not allow the minimum 4-foot clear width continued around obstructions for pedestrians as required by The Public Right-of-Way Accessibility Guidelines (PROWAG).

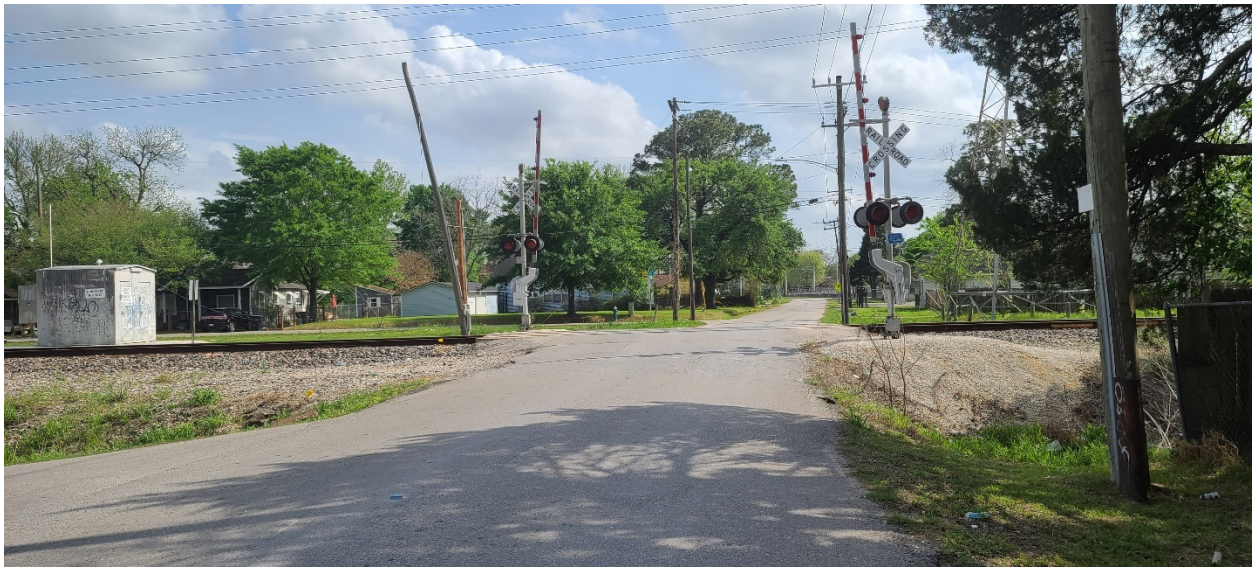
Figure 6. Grade Crossing at Donlen Street

- W10-1 signs on both approaches
- No RR Xing pavement markings on either approach
- Faded stop lines on both approaches
- Grade Crossing Advance Warning sign (W10-4) on Roswell Street

There are no raised medians and the roadway is not wide enough to implement a non-traversable curb to prevent motorists from driving around a lowered gate. A grade crossing advance warning sign (W10-4) on Frisco Street is missing and stop lines at least 8 feet from the gate arm are not present on either grade crossing approach.

- Restrict Roswell Street to operate as a right-in right-out intersection.
- Install 100 feet of channelization devices on the southbound approach. It is noted that under this option, a quiet zone must be requested under Code of Federal Regulation Title 49 §222.39(b) – How a Quiet Zone is Established? **Figure 9** shows graphically the proposed safety improvements.
- Install at least 60 feet of channelization devices on the northbound approach as Frisco Street is within 100 feet of the northbound gate arm.
- Install a Grade Crossing Advance Warning sign (W10-4) on Frisco Street.
- Replace faded stop lines at least 8 feet from the gate arm on each approach.
- Install RR Xing pavement markings on both approaches.
- Ensure gate arm length is within one foot of the roadway centerline.
- As a long-term grade crossing improvement, it is recommended that pedestrian facilities be provided.

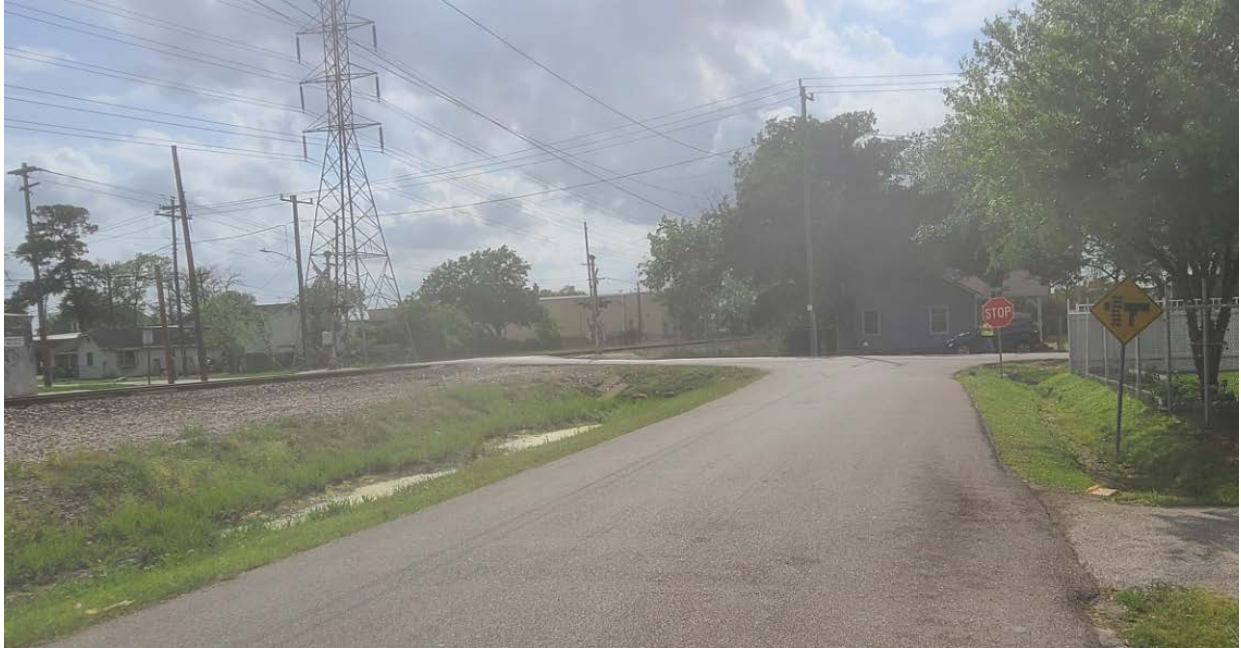
Figure 7. Roswell Street Parallel to the Grade Crossing at Donlen Street

Roswell Street is within 60 feet of the southbound crossing gate and Frisco Street is within 100 feet of the northbound crossing gate.

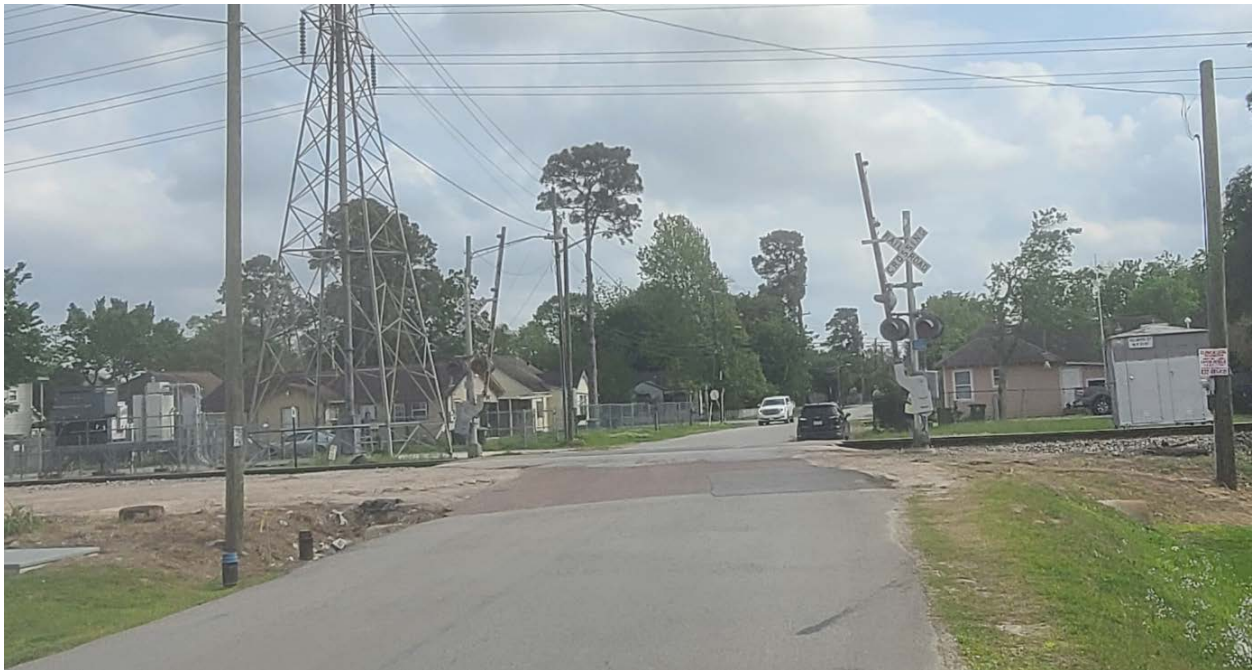
Figure 10. Grade Crossing at Helmers Street (Northbound)

- W10-1 signs on both grade crossing approaches
- No RR Xing pavement markings on either grade crossing approach
- No stop lines on either grade crossing approach

- Install 100 feet of channelization devices from the gate arm on southbound approach
- Install 90 feet of channelization devices from the gate arm on the northbound approach
- Install RR pavement markings on both grade crossing approaches
- Install stop lines on both grade crossing approaches
- At the time of the grade crossing inspection, pedestrians were observed crossing the railroad track. As a long-term grade crossing safety improvement, it is recommended that pedestrian facilities be provided.

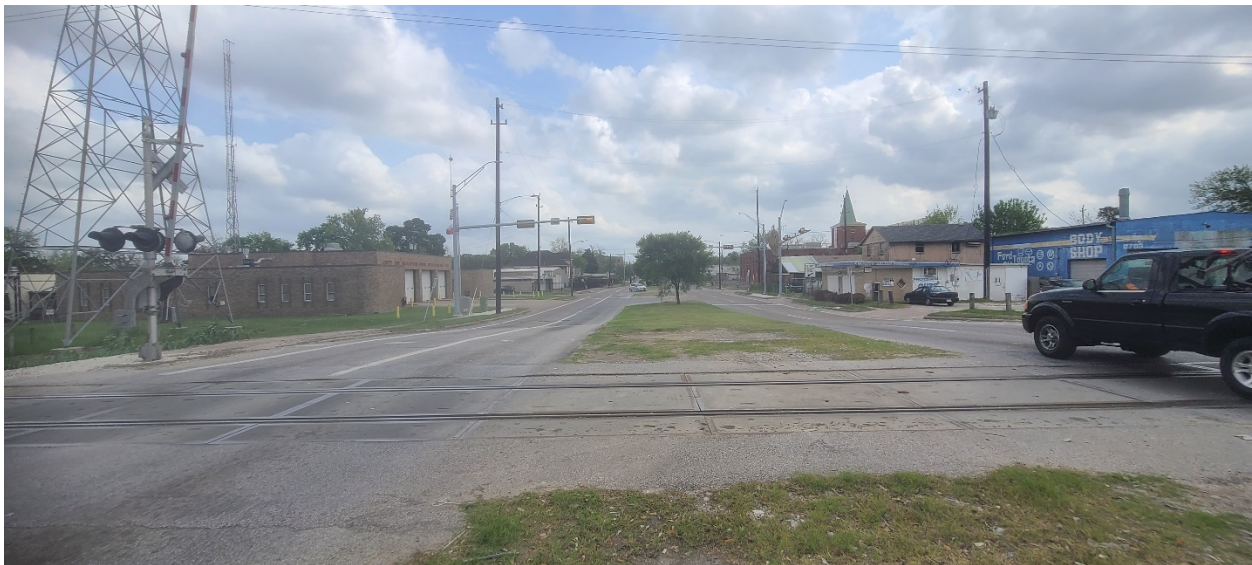
Figure 13. Grade Crossing at Irvington Boulevard (Northbound Approach)

- W10-1 signs on both grade crossing approaches
- RR Xing pavement markings on both grade crossing approaches
- Faded stop lines on both grade crossing approaches

Figures 13 and 14 also show the recently installed emergency signal for the Houston Fire Station 30 just south of the Irvington grade crossing. In the event that the emergency-vehicle traffic control signal is activated to stop traffic, the southbound queue may extend beyond the railroad track. s

- Replace faded RR pavement markings on both bike lanes
- Replace faded stop lines on both grade crossing approaches
- Install a DO NOT STOP ON TRACKS sign (R8-8) on the southbound grade crossing approach to warn motorists not to queue over the track in the event that the emergency signal is activated to stop traffic for the Houston Fire Station 30.

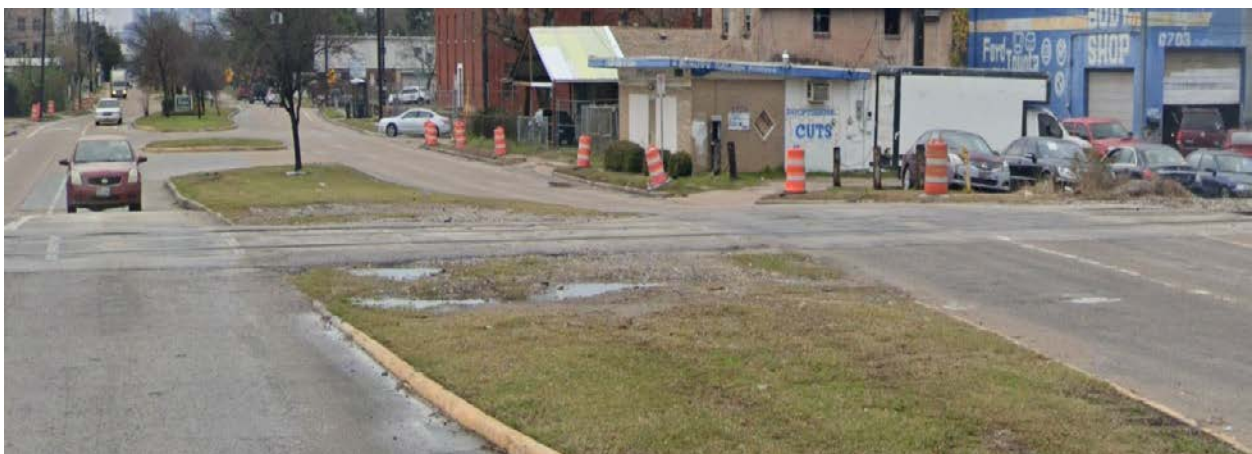
Figure 15. Existing Raised Medians at the Irvington Boulevard Grade Crossing

The top of the existing medians drops to the same elevation as the roadway near the railroad track and cannot prevent motorists from driving around a lowered gate. **Figure 15** shows the existing raised medians.

- Install 6" curb to prevent motorists from driving around a lowered gate on northbound grade crossing approach.
- Replace faded RR pavement markings on both grade crossing approaches

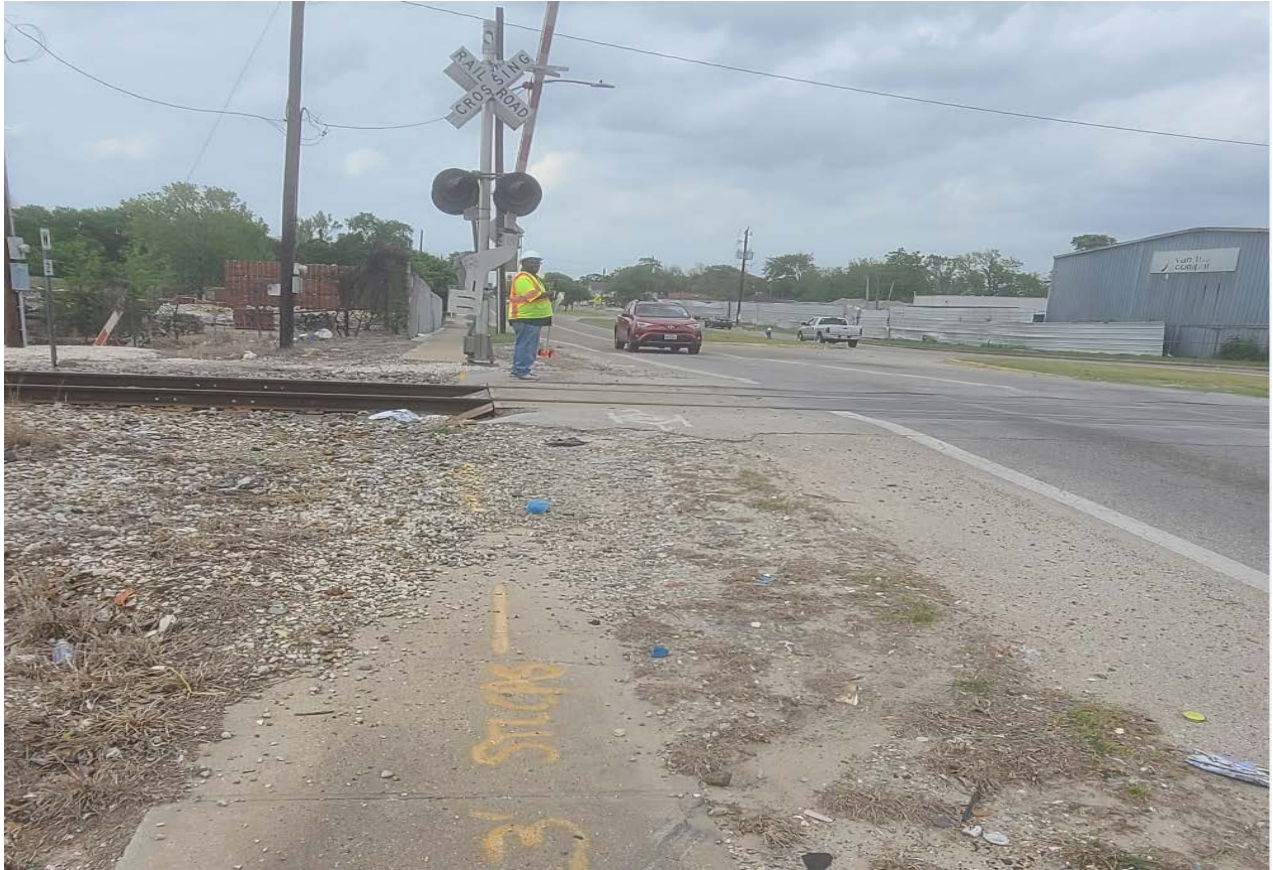
Figure 16. Discontinuous Sidewalk Adjacent to Southbound Approach

Figures 16 and 17 show that the existing sidewalks are not continuous over the railroad track.

- Install additional crossing panels to connect sidewalks across the railroad track
- Install 6" curb on medians on both approaches to prevent motorists from driving around lowered gates.
- Close median opening on southbound approach
- Replace faded grade crossing pavement markings on both approaches and existing bike lanes

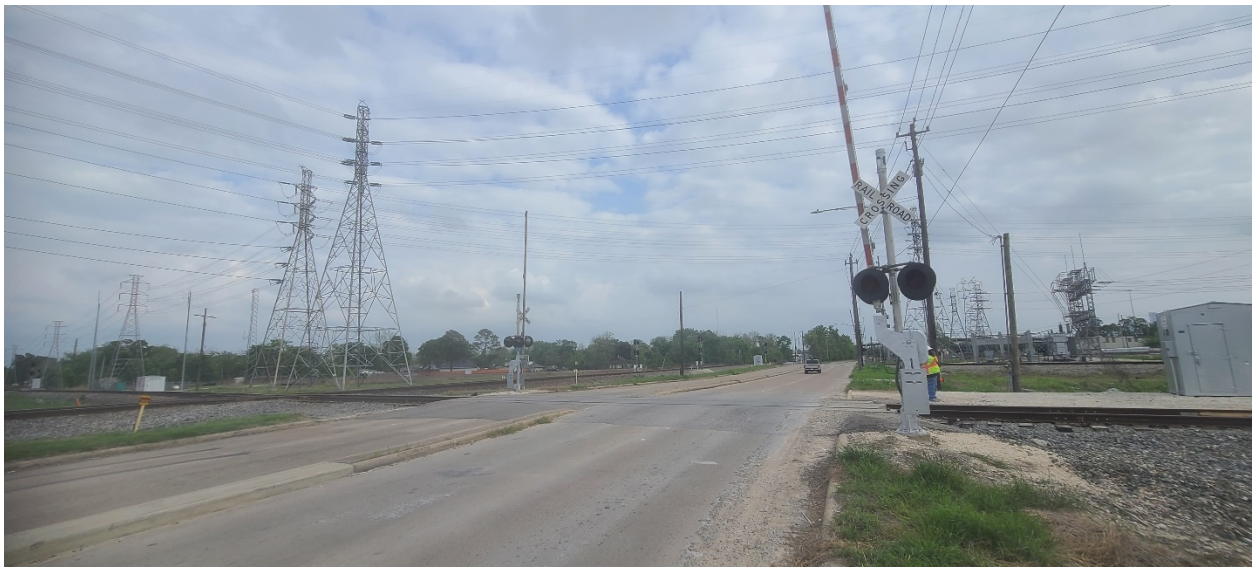
Figure 19. Grade Crossing at W. Hardy Street (Southbound Approach)

- No W10-1 signs on either grade crossing approach
- No RR Xing pavement markings on either grade crossing approach
- No stop lines on both grade crossing approaches

- Stop lines are missing on each grade crossing approach
- No grade crossing advance warning (W10-1) signs on either approach
- No RR Xing pavement markings on either approach

- Install RR pavement markings on both grade crossing approaches
- Install stop lines on both grade crossing approaches
- Install grade crossing advance warning sign (W10-1) on each grade crossing approach
- Ensure gate arm length is within one foot of the raised median
- Replace existing raised median with 2-ft raised median with 8" curb height on both approaches to accommodate future roadway overlay

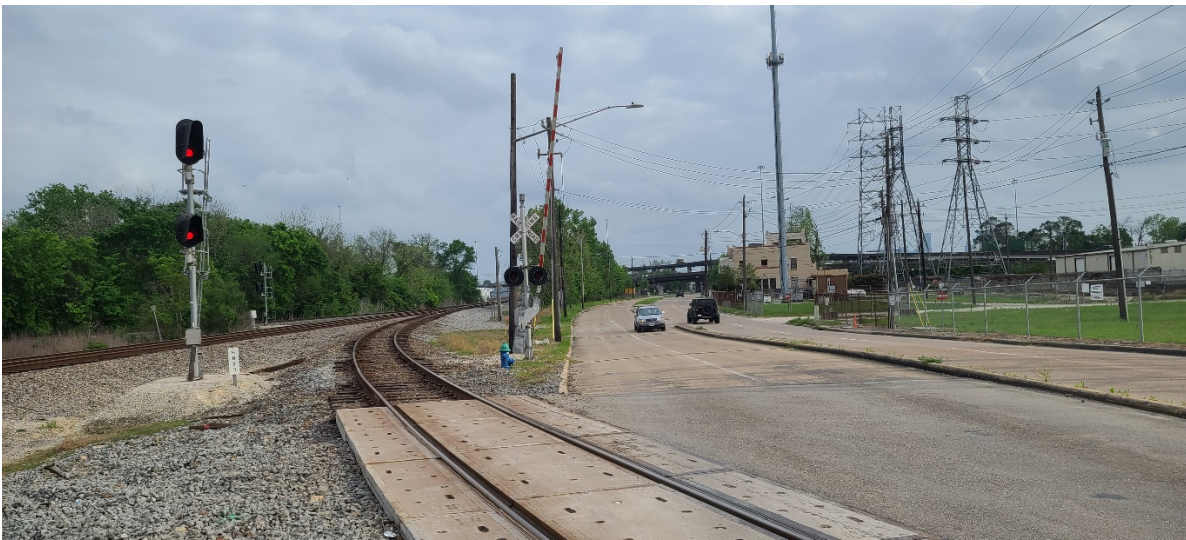
Figure 22. Grade Crossing at W. Hardy Street (Southbound Approach)

- No W10-1 signs on either grade crossing approach
- No RR Xing pavement markings on either grade crossing approach
- No stop lines on both grade crossing approaches

- Stop lines are missing on each grade crossing approach
- No grade crossing advance warning (W10-1) signs on either approach
- No RR Xing pavement markings on either approach

- Install RR pavement markings on both grade crossing approaches
- Install stop lines on both grade crossing approaches
- Install grade crossing advance warning sign (W10-1) on each grade crossing approach
- Ensure gate arm length is within one foot of the raised median
- Replace existing raised median with 2-ft raised median with 8" curb height on both approaches to accommodate future roadway overlay
