**Study Report**  
**For**  
**Porter Road Segment 3**  
**Morton Ranch Road to Clay Road**

**Harris County, Precinct 3**

November 2021

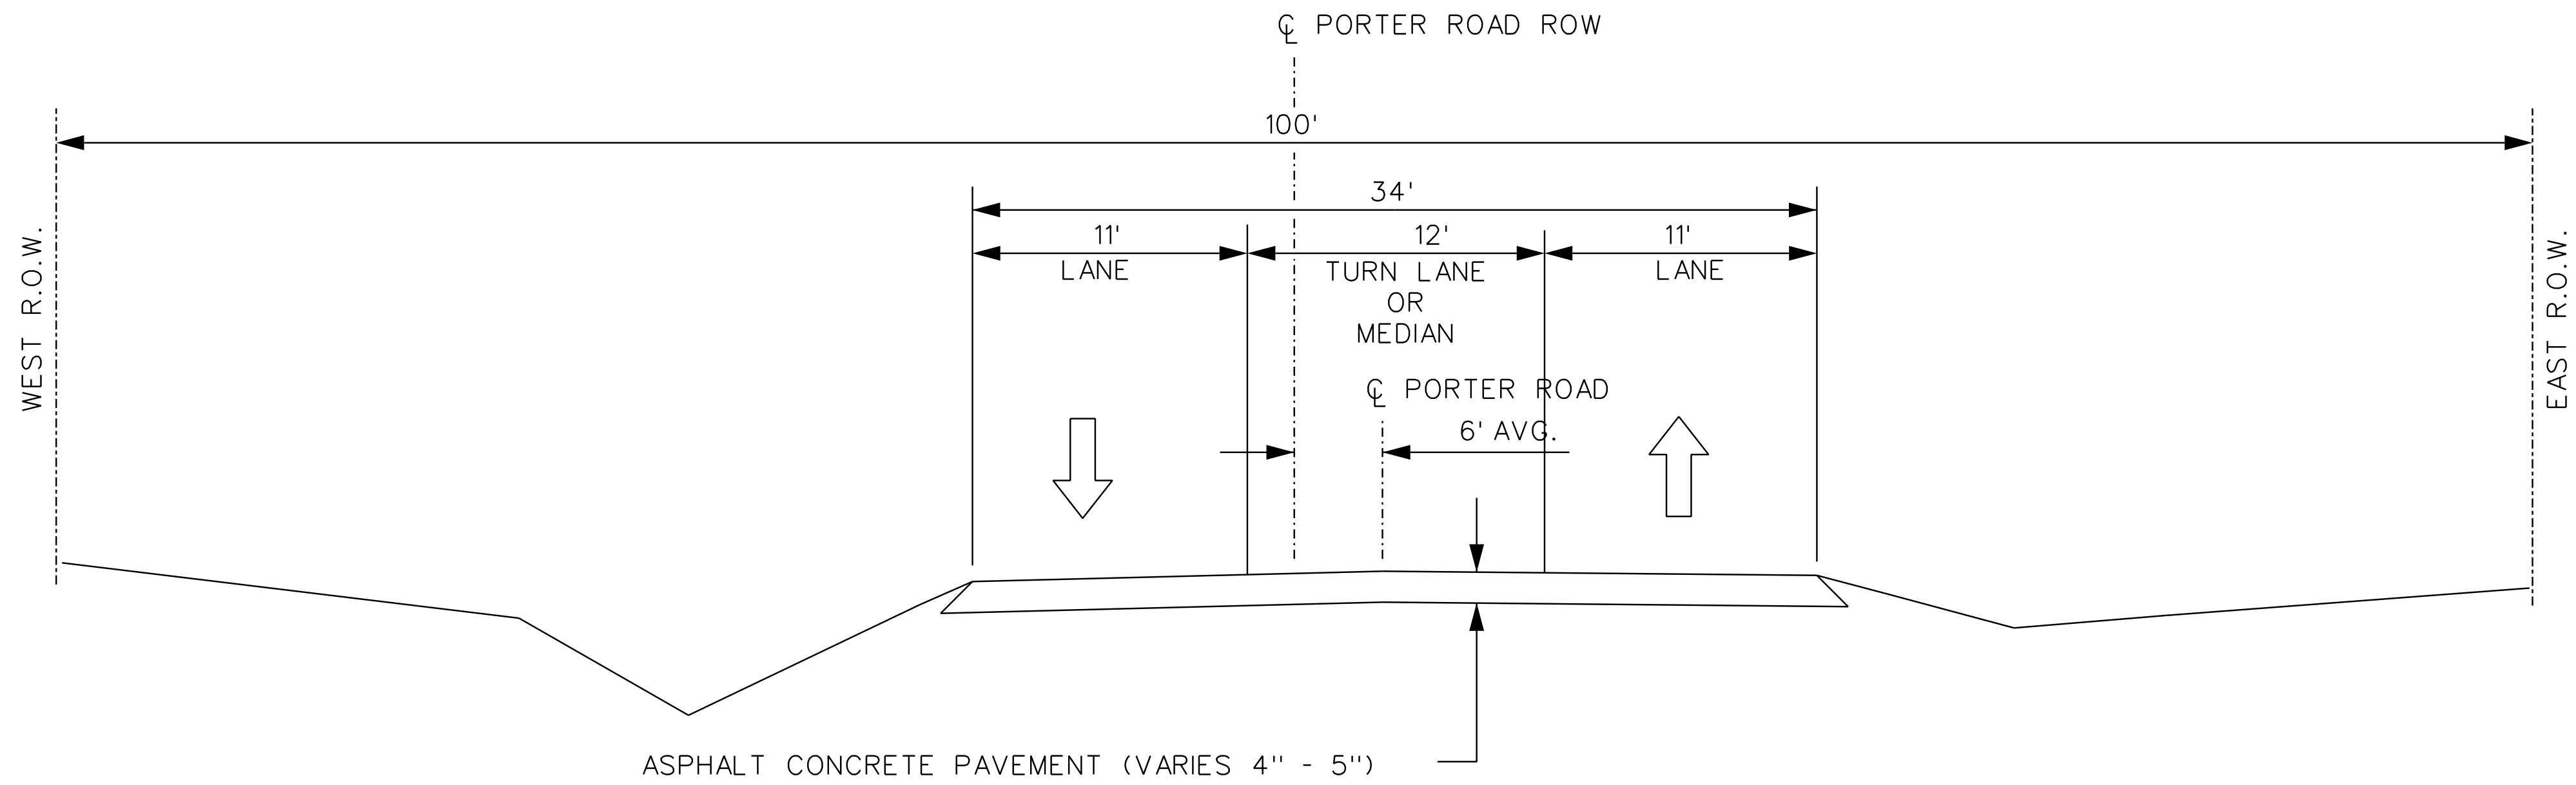
EXISTING TYPICAL SECTION  
STA. 8+00 TO STA. 32+00

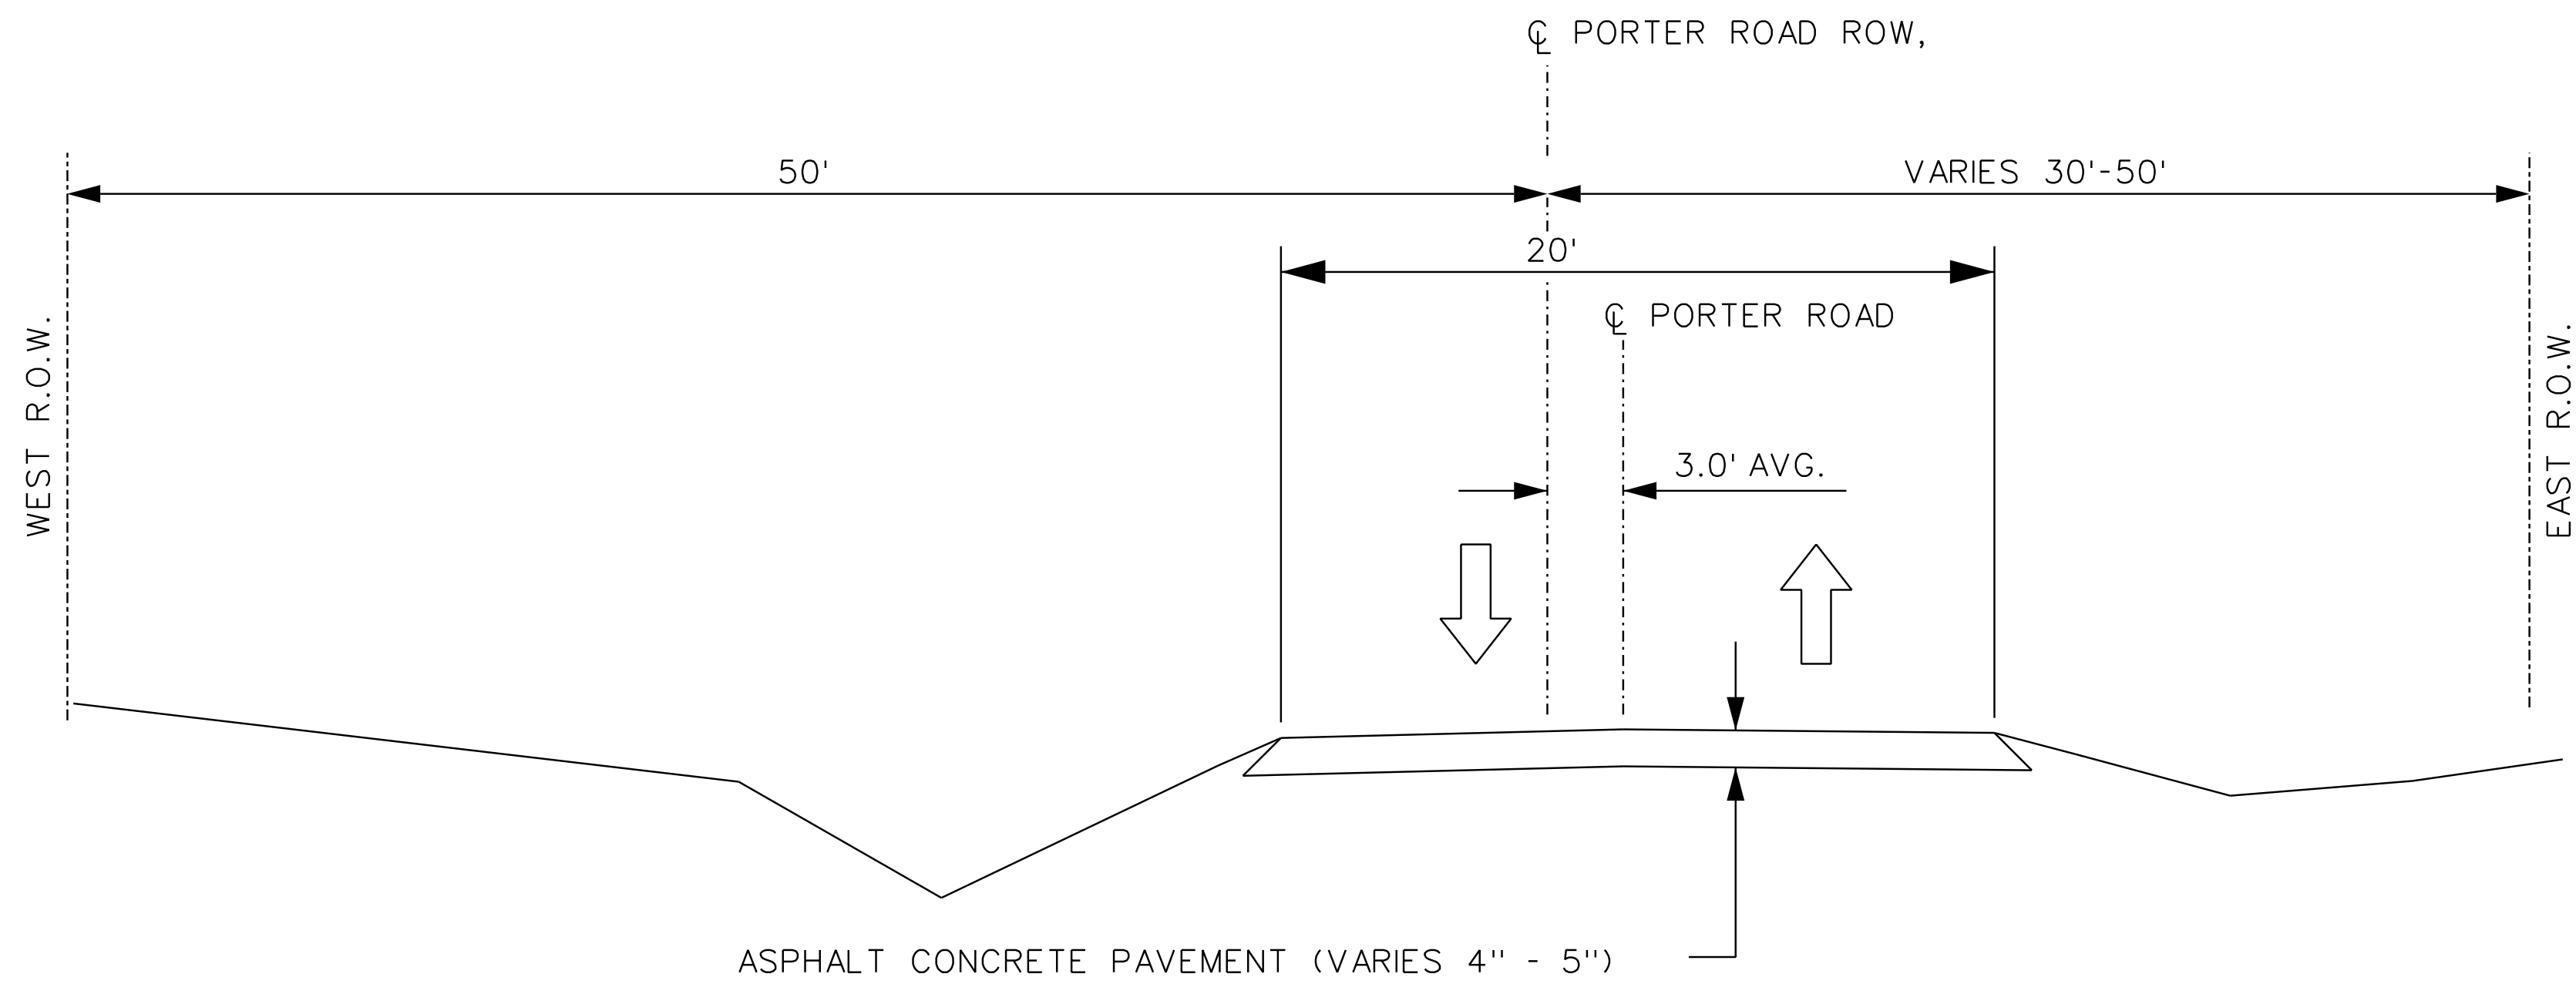
EXISTING TYPICAL SECTION  
STA. 32+00 TO STA. 45+50

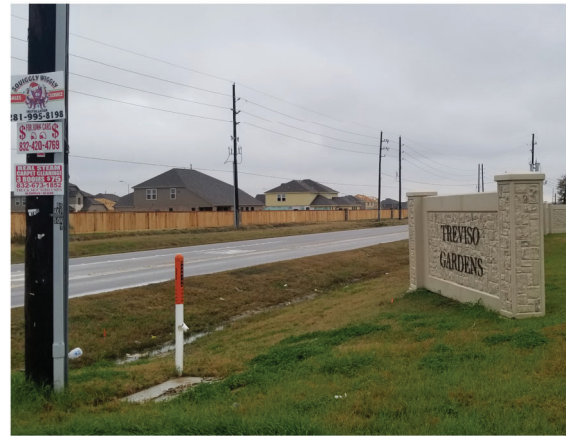
AT AVOGADRO DR  
FACING EAST, LOOKING SOUTH ON PORTER ST  
(@ APPROXIMATELY 25-FT SETBACK)

OBSTRUCTION IN SIGHT TRIANGLE FROM VIEWING  
TRAFFIC APPROACHING FROM THE SOUTH.  
RECOMMEND REMOVE STUCCO WALL.

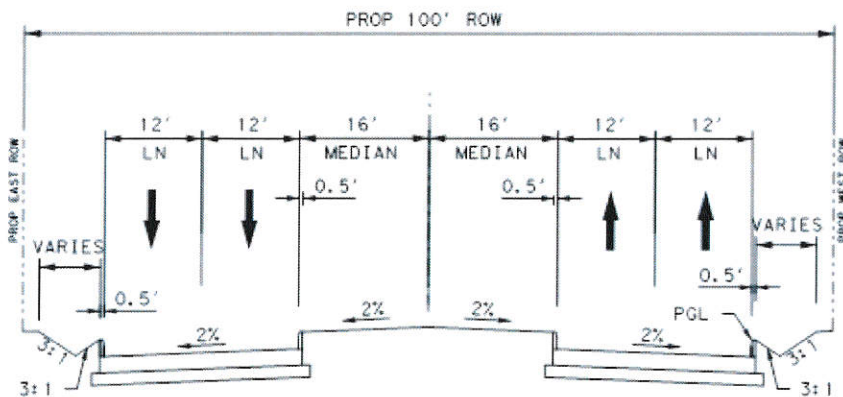
Figure 3: Typical cross section for proposed conditions for Porter Road.

The proposed ROW is assumed to be 100-foot wide and contain 4 lanes at 12-feet wide with a median of 14-foot wide (**Figure 3**). Impact analysis for existing versus proposed conditions assumes:

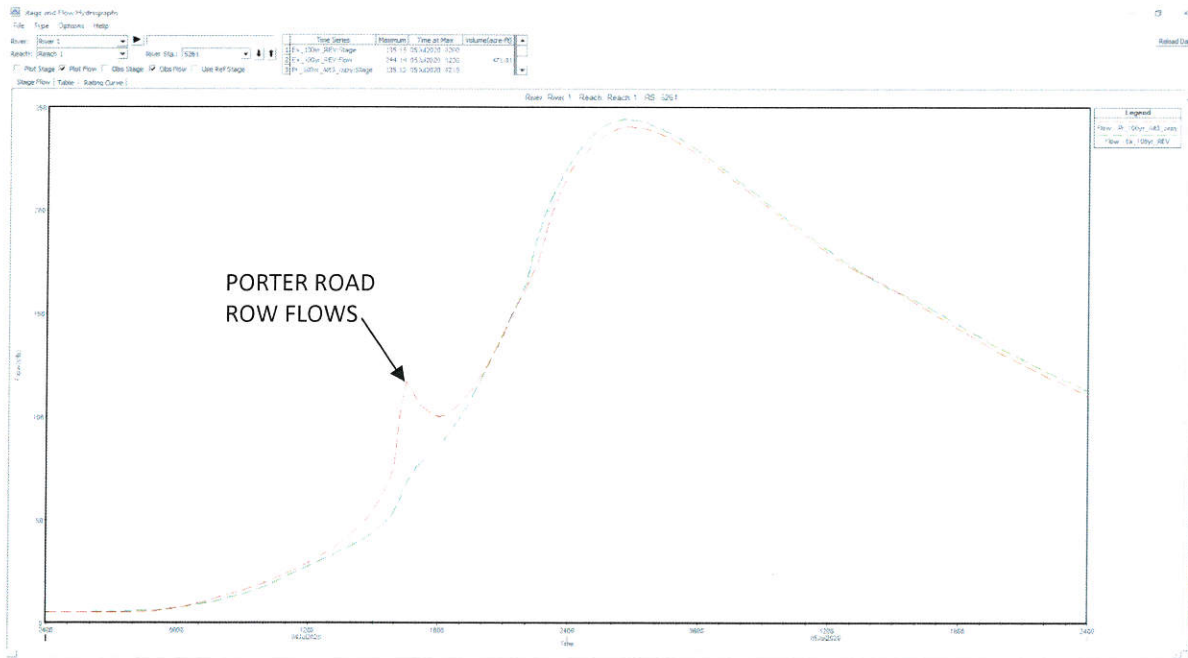
Figure 10: 100-Year hydrograph comparison of proposed alternative 2 and existing conditions.

The peak 100-year flow into U101-08-00 from the Porter Road ROW is approximately 45 cfs and the proposed conditions peak 100-yr flow is approximately 130 cfs. Despite the increase in flows from the ROW there is no impact to stage or peak flow in U101-08-00. This is due to the large offsite areas being drained through internal detention basins and the timing of the peak flow in the channel. **Figure 10** provides the 100-year hydrograph comparison of existing and proposed conditions just downstream of Porter Road. The initial spike in peak in flows is from the Porter Road ROW which can be seen to occur well ahead of the larger peak flow from the upstream drainage areas.

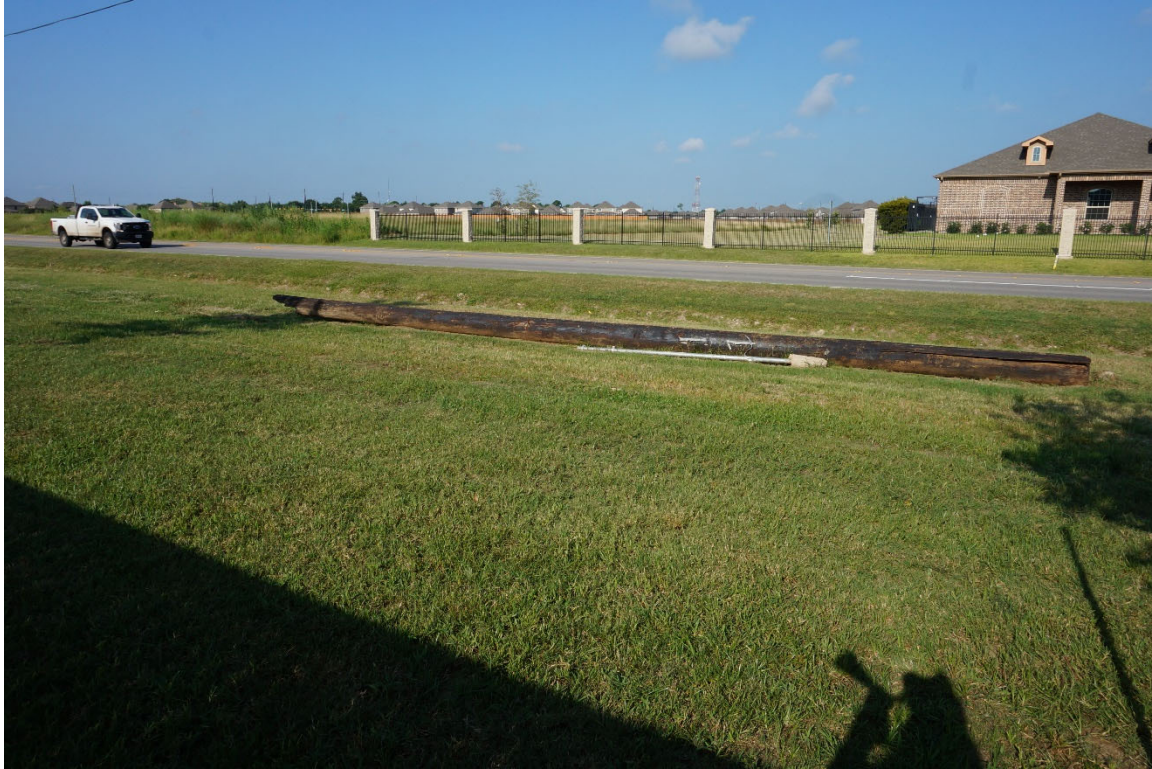
Photograph 17: Damaged creosote telephone pole alongside of Porter Road near Treviso Gardens Rd
